DAMAGE DUE TO STRANDING

Vessel name:	Melody

Registered port:	St John, USVI	
Assured:	Martin Andersson	
Hull identification number:	CAT47120B000	
Vessel description:	2000 model Catana 471 FRP sloop rigged catamaran with twin auxiliary diesel engines. Approximate dimensions 47'L x 25'B x 5'D (measurements not taken).	
Policy #:	CSRYP/172119	
Status:	Recommended to Underwriters as a Constructive Total Loss pending coverage.

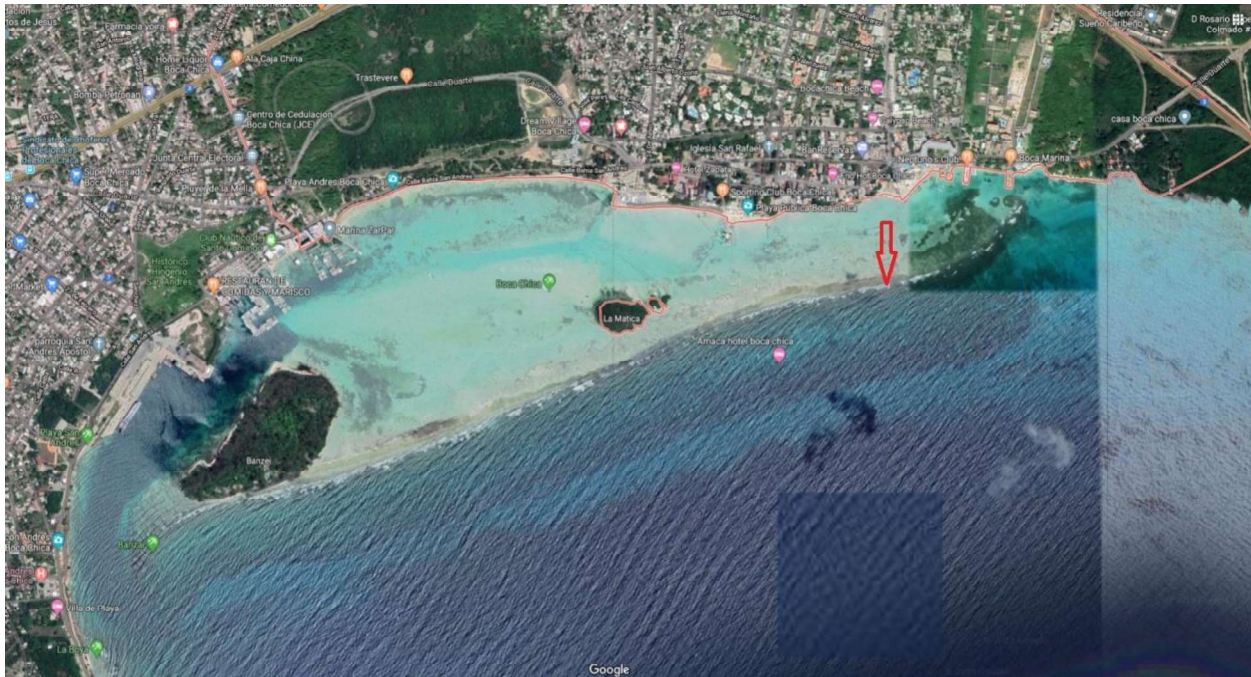
Satellite view of breakwater. Red arrow denoting approximate location of stranded vessel. The entrance to the harbor is on the far left.

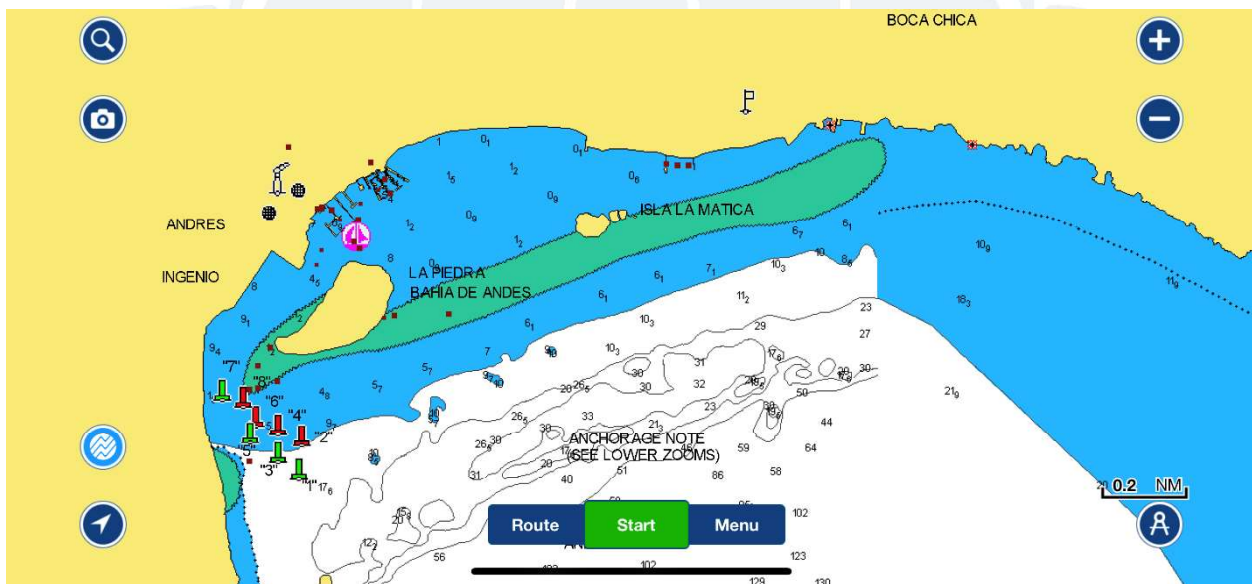
Breakwater shown on the latest Navionics chart data

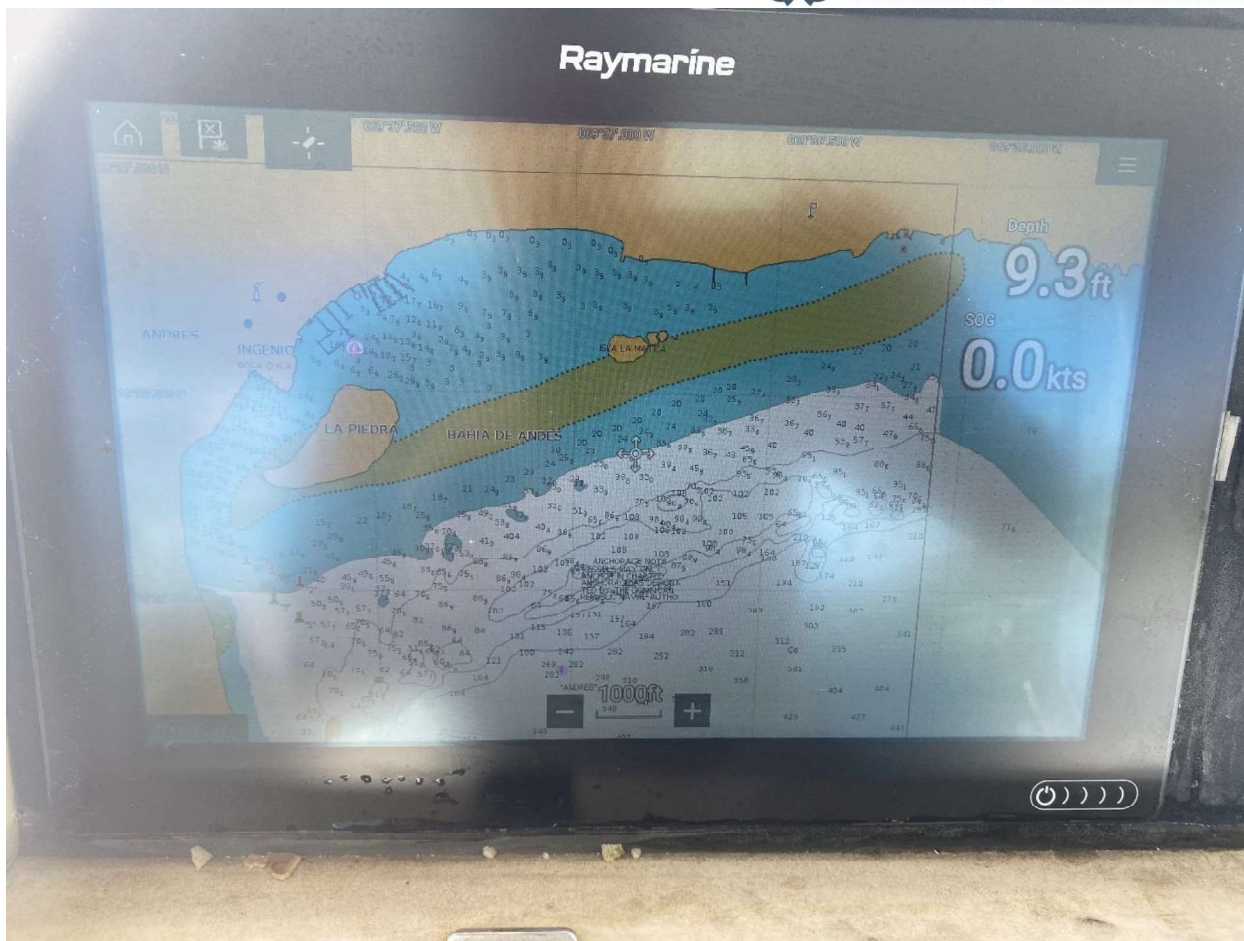
>2 year old chart data taken from our company vessel.

The breakwater is unlit at night.

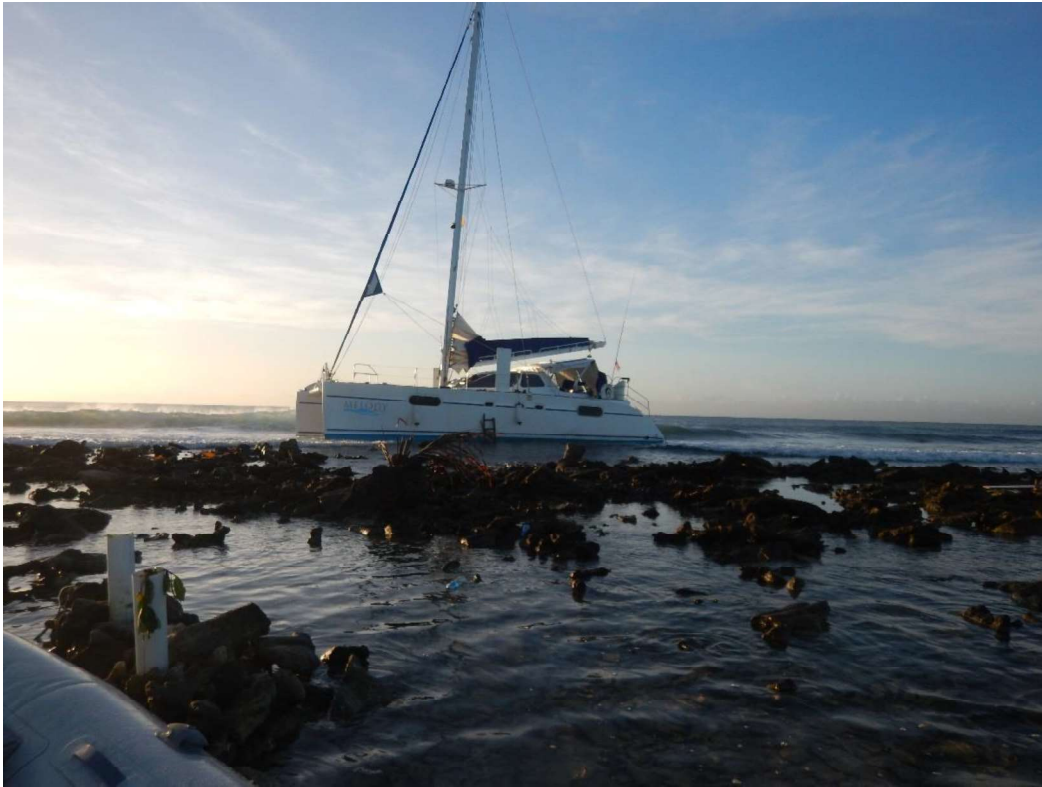
Vessel in current position

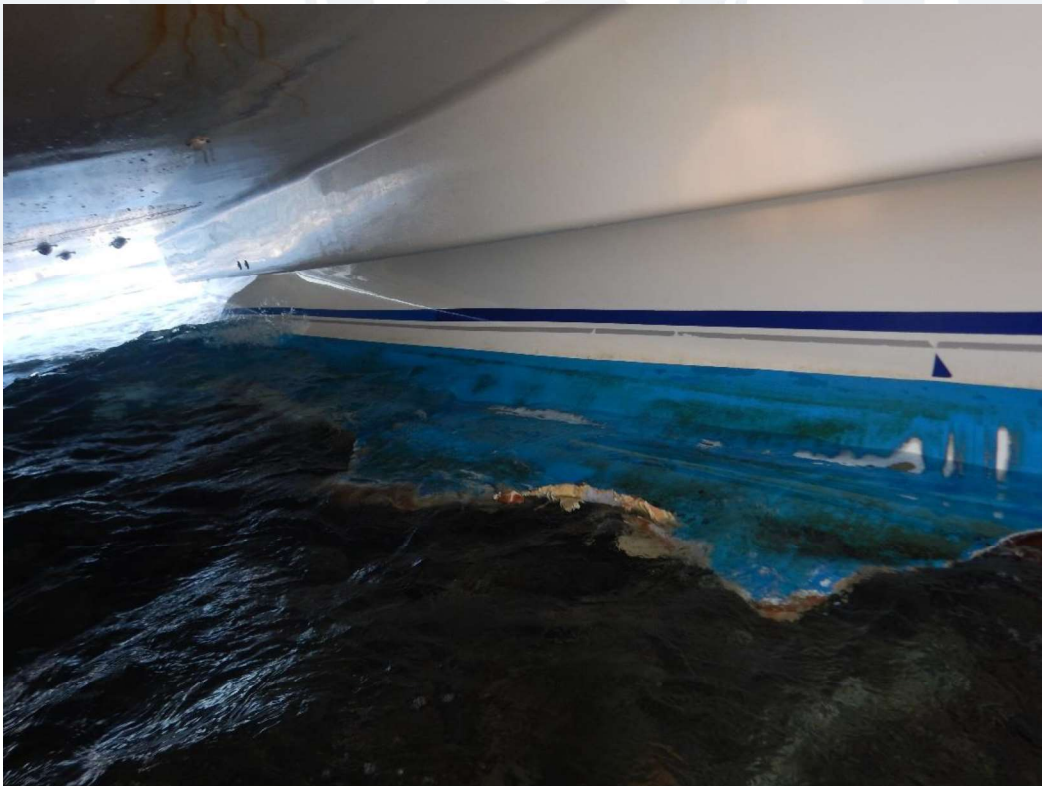
- The bottoms of both hulls are severely damaged. The breakwater is clearly visible from the inside of the vessel.
- The topsides are broken in large areas and badly deformed in others.

Broken hull bottom extending to topsides inboard port hull

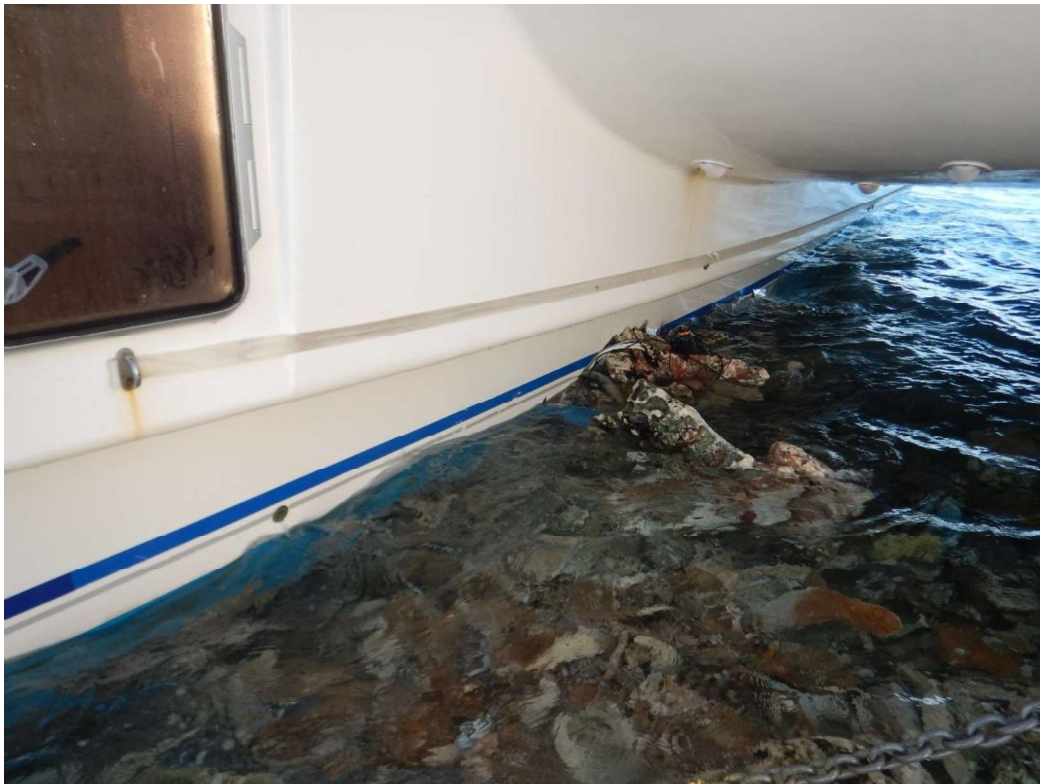
Impacted rock, starboard hull

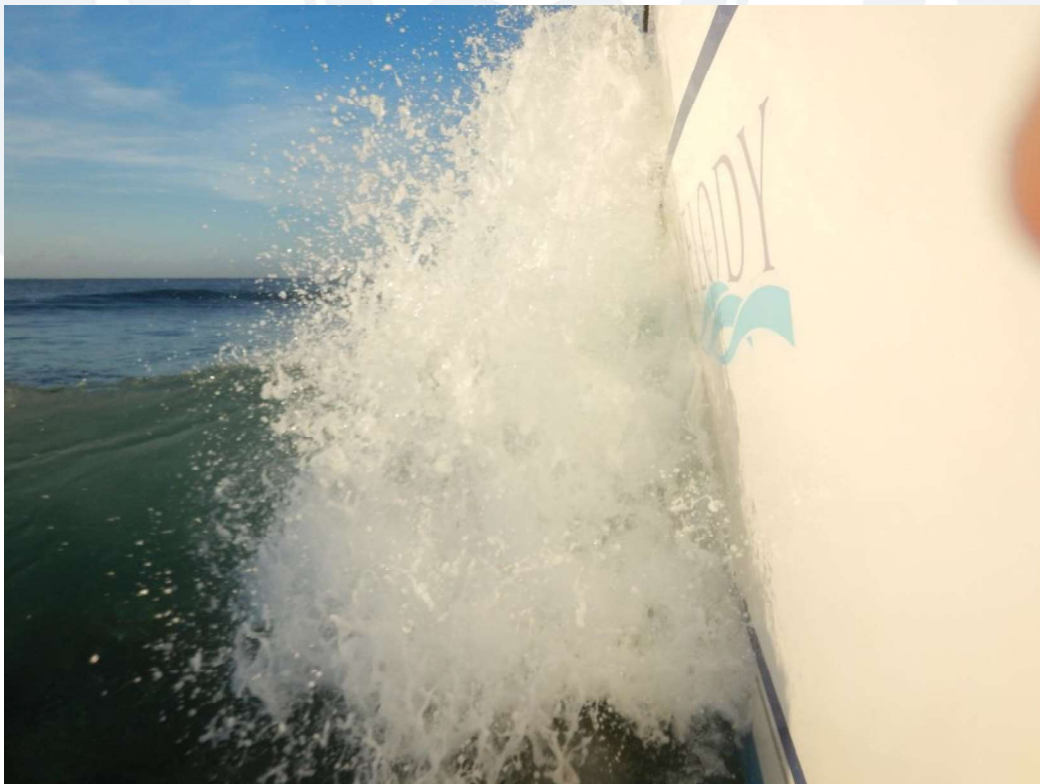
Wave action on seaward side

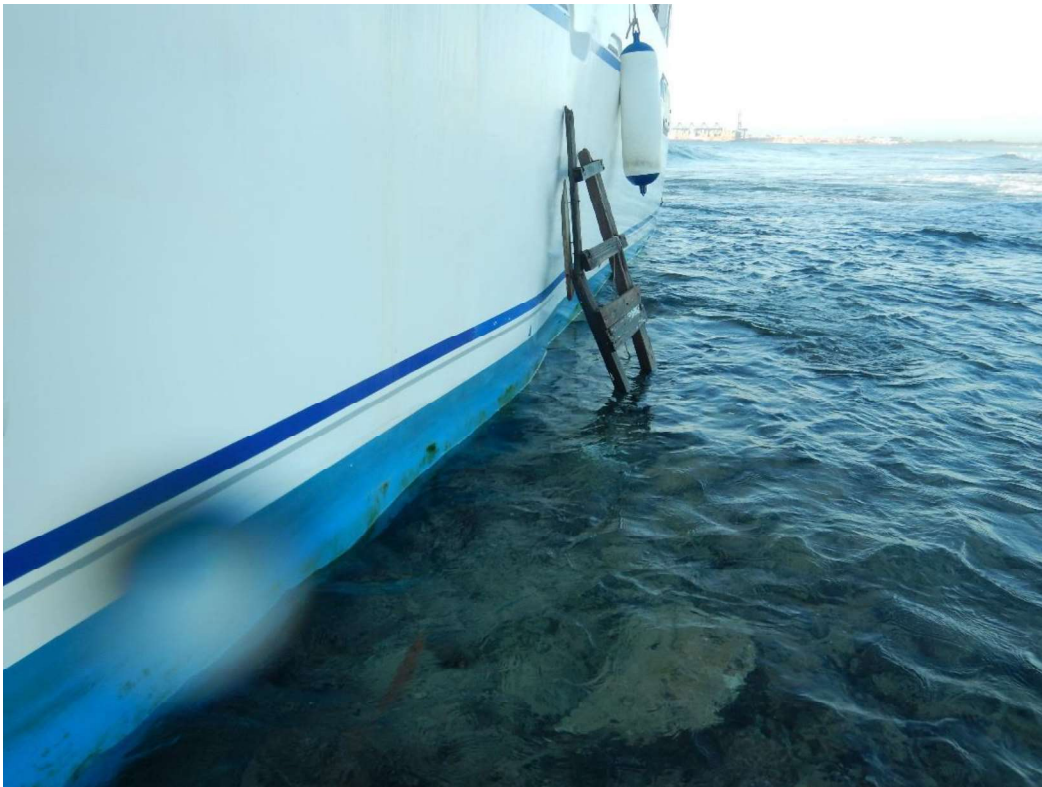
Deformed topsides outboard side, port hull.

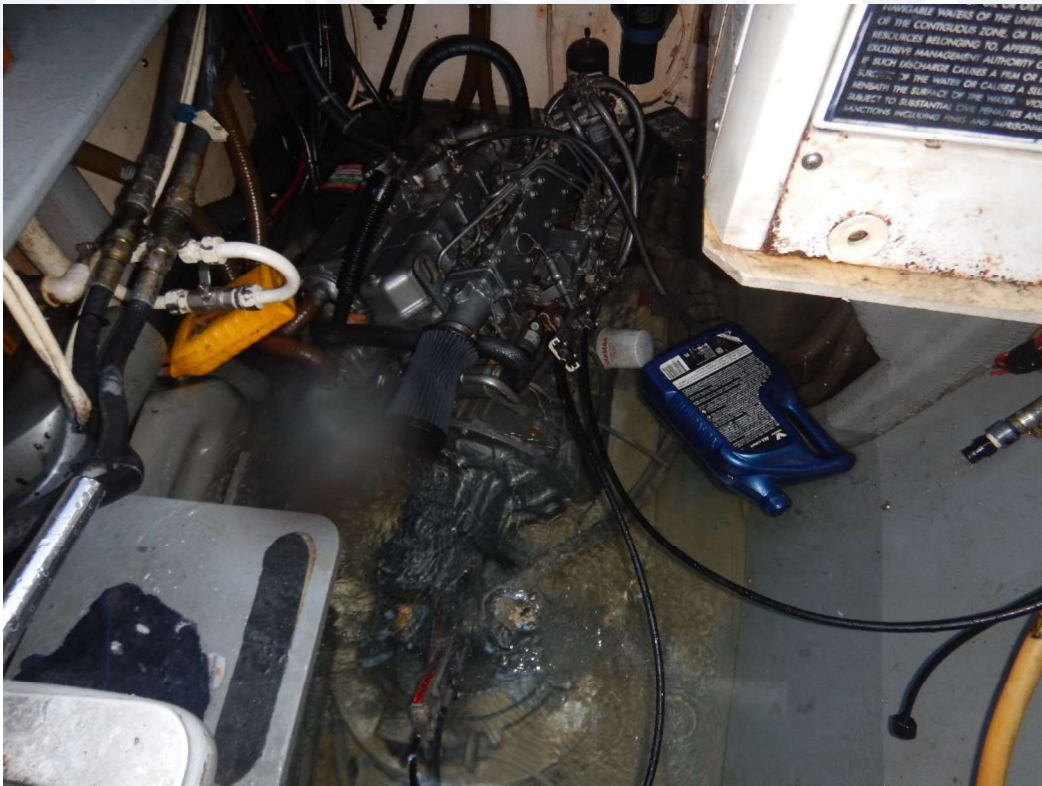
- Both engines have been broken from their mounts by forces from below. They lie on their sides partially submerged.
- It is our opinion that the damages to the engines are beyond those of economical repair.

Port engine

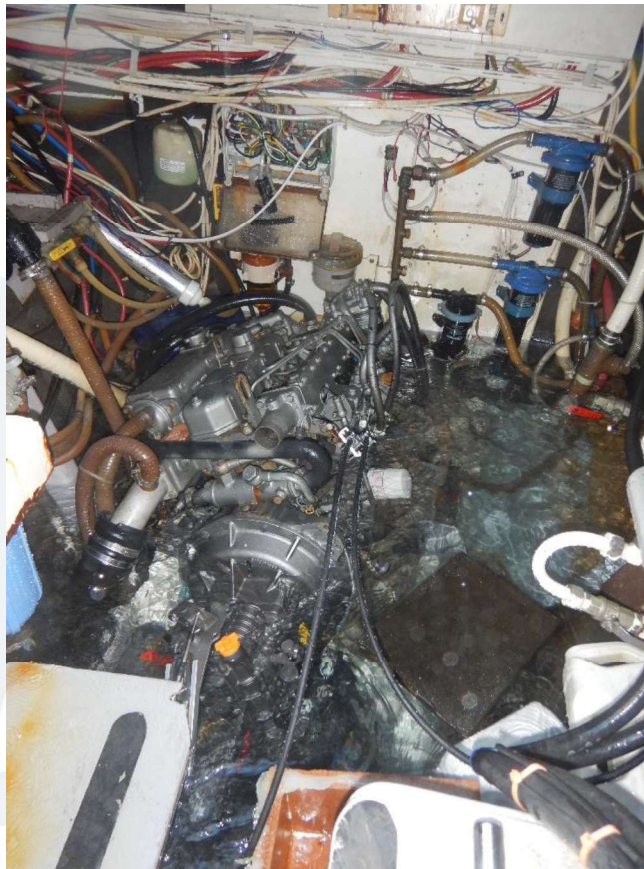
Starboard engine

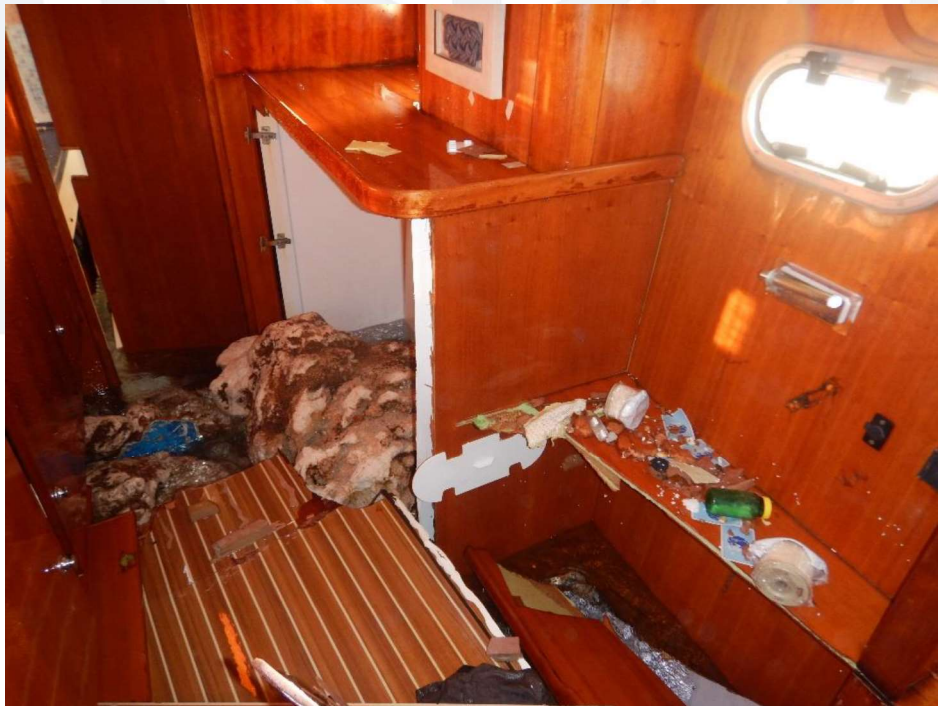
- The water level is approximately 1.5' above the cabin soles in both hulls. The continuous pounding from the swell has caused much of the cabinetry to break apart.
- All soft goods on the interiors of the hulls are also now wet.
- Only the area on the bridgedeck remains dry.

Starboard hull interior (breakwater)

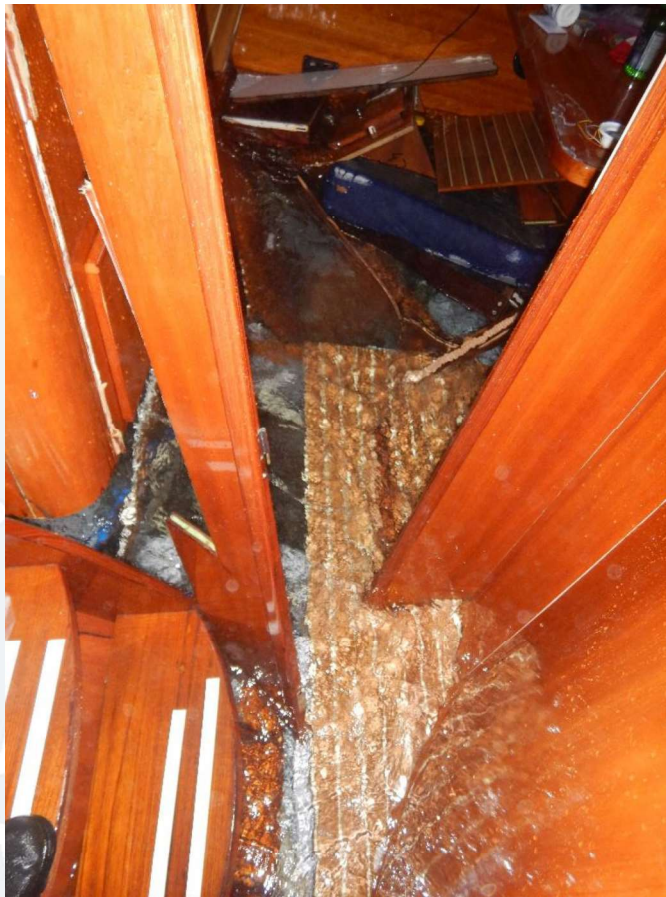
Port hull interior

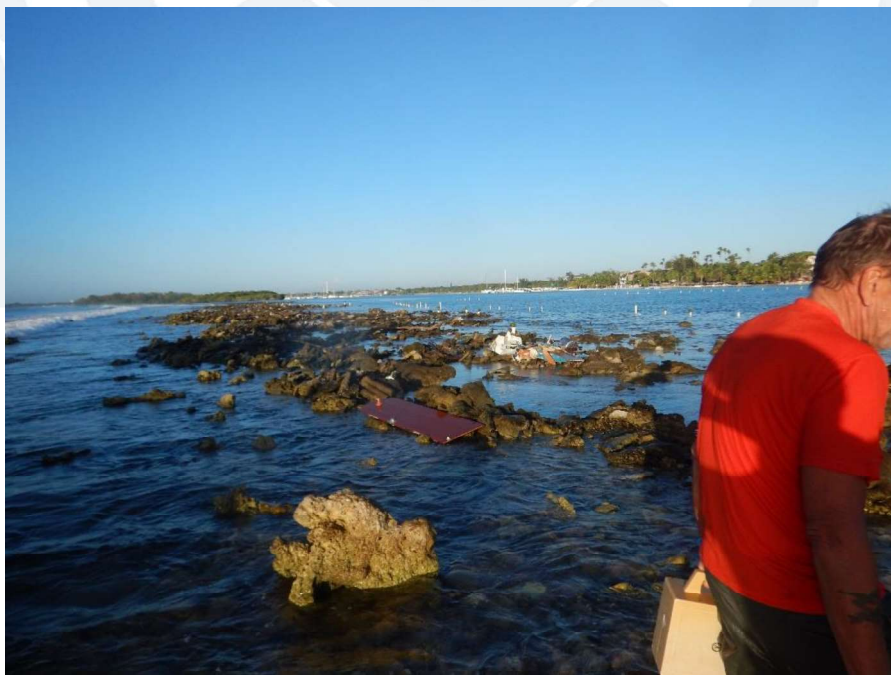
Debris on breakwater
